# Water Bag and Concertainer Detonation Barricades

ARL-TR-2330 September 2000

#### **Abstract**

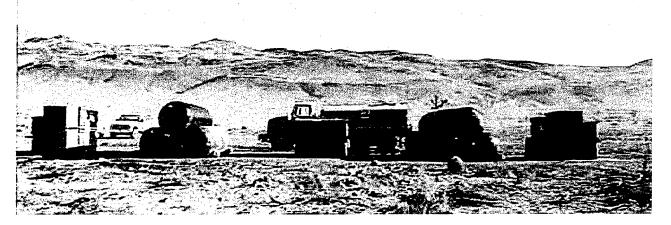
Figure 4. Water Bag Setup for MST 1.1 Hazard Test.

Water or sand are flung by the blast. See large water spray front, inset Figure 4, and large sand spray front, Figure 8. Barricades do not impact acceptor stacks as a sliding, intact object. Impact on acceptor stack may be low.

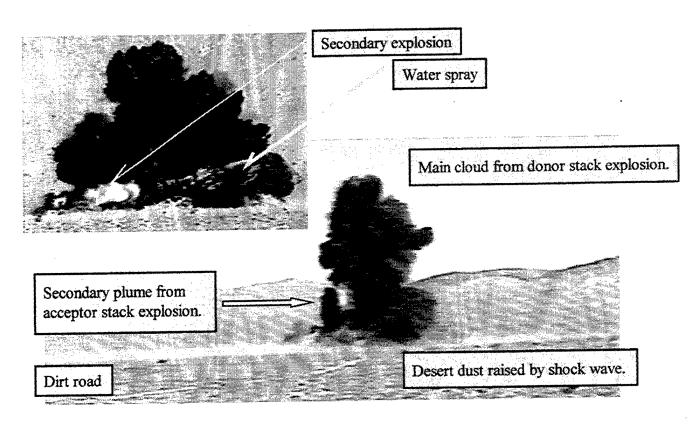
Figure 5. Explosion of North Acceptor Stack Shown by Secondary Dirt Cloud.

2.1.2 Results. The donor stack fully detonated. Both barricades were destroyed in place, and the water was driven out in a spray at the acceptor stacks. The north end acceptor stack fully detonated, but the south end acceptor stack did not. The secondary explosion is revealed by the smaller dirt column in Figure 5. There was a very large, black-crusted ground area left by the water blast interaction. The cause of the darkening is unknown, but possibly water vapor condenses on carbon particles in the donor explosion TNT after-products and falls as black rain. The particles would have to be very small to be carried by the slight wind and blacken the large area that was observed. Figure 6 shows scattered munitions on the darkened ground.

Other signs of the secondary explosion are the mangled steel witness plates that were under the acceptor stack, the creation of a large crater north of the (separate) donor stack crater and no crater south of the donor stack crater, the disappearance of all acceptor munitions from the north stack, and the explication of high-speed film. Selected frames of the event are shown in Figure 7. After interpreting the film, we concluded that after a long delay from stack initiation (camera speed unavailable), a single-point intiation occurred on the ground 10 ft behind the acceptor stack face (probably in an M2 munition), and detonation propagated to all other munitions of that stack.

<sup>\*</sup> Repeated ground sweeps recovered no munitions at all. In particular, the conspicuous, inert 155-mm projectile encasing the accelerometer was not found; its disappearance further signifies that the north stack entirely detonated.

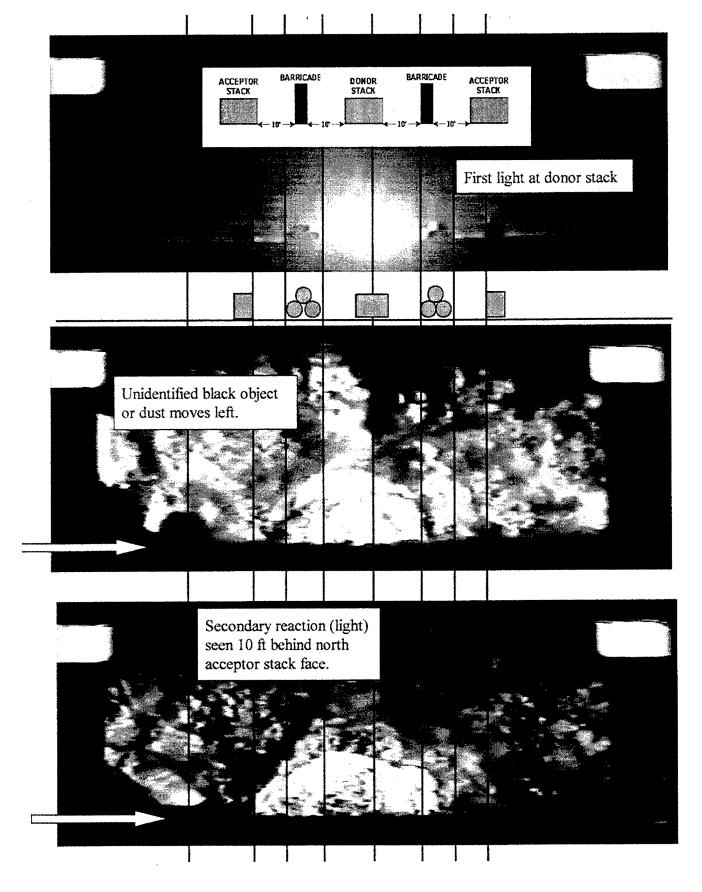
Figure 7. Secondary Explosion in North Acceptor Stack of Water Bag Test.

The acceptor stack that detonated did so after a considerable delay, as indicated by the fact that the point of initiation is seen on film to be 10 ft behind the barricade side of the stack. It is clear that water impact did not cause prompt initiation. In both barricade tests, some of the lightly packaged and constructed M2 shaped charge hole diggers were ripped open, and crumbled Pentolite explosive was scattered near the item (see Figure 11). It is possible that a deflagration to detonation transition occurred in this broken Pentolite, but this is unlikely. M2A3 hole diggers (Composition B fill) were shown by Lyman et al. (1994) to be very sensitive to crushing impacts. This is because the explosive is almost completely unprotected. We suspect that the crushing of the hole diggers caused the initiation. The likeliest cause of the initiation was mutual impacts in a group of translating munitions that crushed the explosive. Possibly the light and sensitive M2 hole digger collided with others or with the backing, which were heavy, semistationary M107 projectile pallets, and the Pentolite was crushed and initiated. If collision and crushing caused the initiation, then it could just

The acceptor stack probably detonated because the M2 shaped charge hole diggers collided with themselves or against other slower traveling munitions; the driver explosive was then crushed and initiated, exploding the swarm.

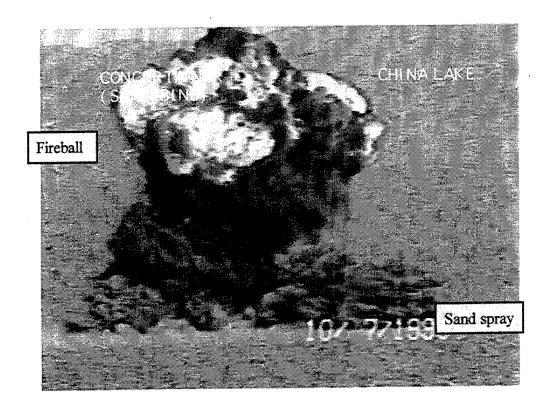
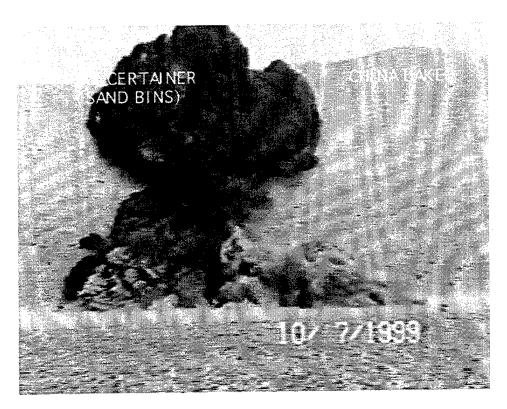
Figure 9. Explosion Cloud and Sand Spray From Concertainer Test.

- 2.2.2 Results. The donor stack fully detonated. Both barricades were destroyed in place and the sand was driven out in a spray far beyond the acceptor stacks, as shown in Figure 9. Neither acceptor stack detonated, as revealed by the curled but intact steel witness plates under the stack, the lack of acceptor craters, the recovery of the acceptor munitions, and a review of high-speed film. All stack items survived being translated close and far, and all were recovered. Views of thrown munitions are shown in Figure 10. The heavy RAP projectiles from the front of the acceptor stack are the closest to the witness plate. No baseplate on the RAPs was dislodged, so no submunitions were spilled. Figure 11a shows that the blast damaged the light packaging of the M2 hole digger, which is three nestled SCs wrapped in plastic and put in a narrow wood box. Bunches of boxes are banded together. Figure 11b shows an SC broken open, exposing the driver explosive.

a. Early time showing fireball and large sand spray to right.

b. Later time showing fireball nearly gone and sand at maximum throw.

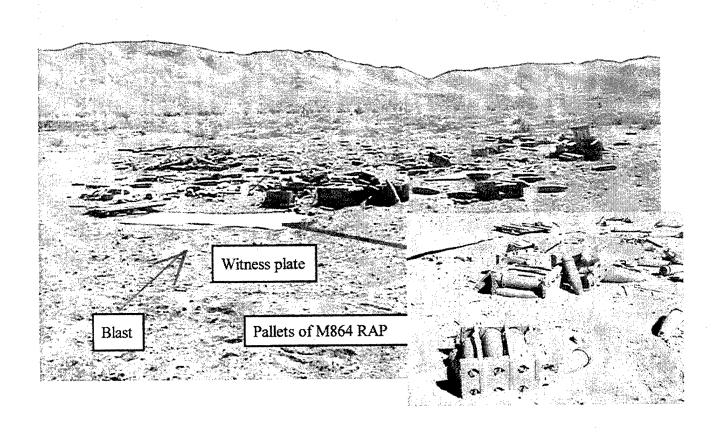
Figure 10. Field of Thrown Munitions From Concertainer Test.

No munitions from either stack had fragment marks. In other words, the upper (4G) bin at a thickness of 60 in and linear density of 1,600 lb/ft stopped fragments from the 155-mm HE projectiles. This result was expected from Johnson (1966), who found that fragments off of the 8-in howitzer projectile M106 penetrated less than 4 ft of sand; therefore, the Concertainer barricade we designed (Appendix A) was thicker than needed. The accelerometers read 5,000 g on the north stack and 3,200 g on the south stack.

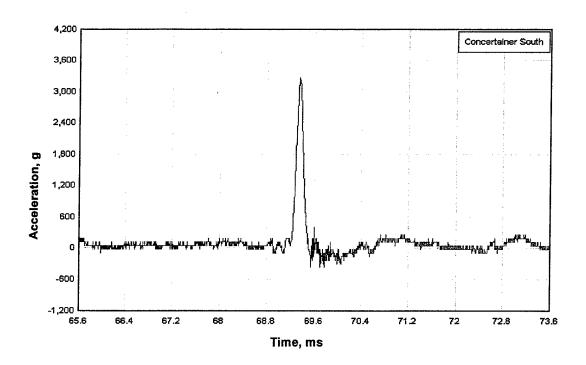
Figure B-2. Accelerometer Record in Water Bag Test.

In the water bag test, one of the acceptor stacks went high order, and its HDAS round was not found. Figure B-2 shows the one water bag record. For the Concertainer test, both rounds were recovered, and the data are shown in Figure B-3. The acceleration measured in both tests was between 3 and 5 kg, much below a full-scale record. Even so, because of the wide dynamic range of the HDAS, clean data were extracted.

Ground shock probably triggered the HDAS. That short delay time from donor stack detonation until ground shock arrival is not included on the records. Neglecting it for the nearly identical size tests, the motion of the water bag acceptor stack begins 50 ms after time zero and after 70 ms for the Concertainer acceptor stacks.

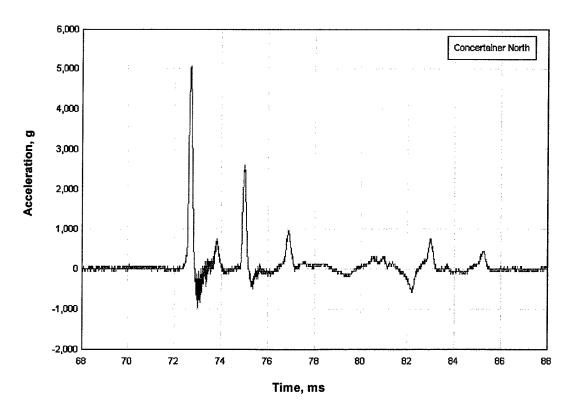
Figure B-3. Accelerometer Record in Concertainer Test.

a. Accelerometer Position: Rear Middle of South Acceptor Stack.

b. Accelerometer Position: Rear Middle of North Acceptor Stack.
